SAFE PRACTICES *in Patient Care*

Helping to promote a culture of safety

In April 2006, the Joint Commission on Accreditation of Healthcare Organizations (JCAHO) issued a *Sentinel Event Alert* that urged healthcare organizations to pay special attention to how tubes and catheters are connected to patients. Reports to JCAHO, ECRI, FDA, and the United States Pharmacopeia (USP) show that tubing and catheter misconnection errors occur frequently and lead to deadly consequences in many instances. The reality prompted JCAHO to issue the *Sentinel Event Alert* to more than 12,000 healthcare organizations nationwide, including hospitals, ambulatory care centers, home care agencies, and nursing homes, to create a new awareness of the problem and to offer practical solutions to avoiding occurrences. Beverly Gallauresi, Melissa Eakle, and Audrey Morrison, nurse-consultants with the FDA, have been monitoring misconnections events over the past few years. In their article they point out that Luer connector misconnections continue to occur because Luer connectors are widely available, easy to use, and inexpensive. Following JCAHO recommendations on proper practice is part of the solution, as i

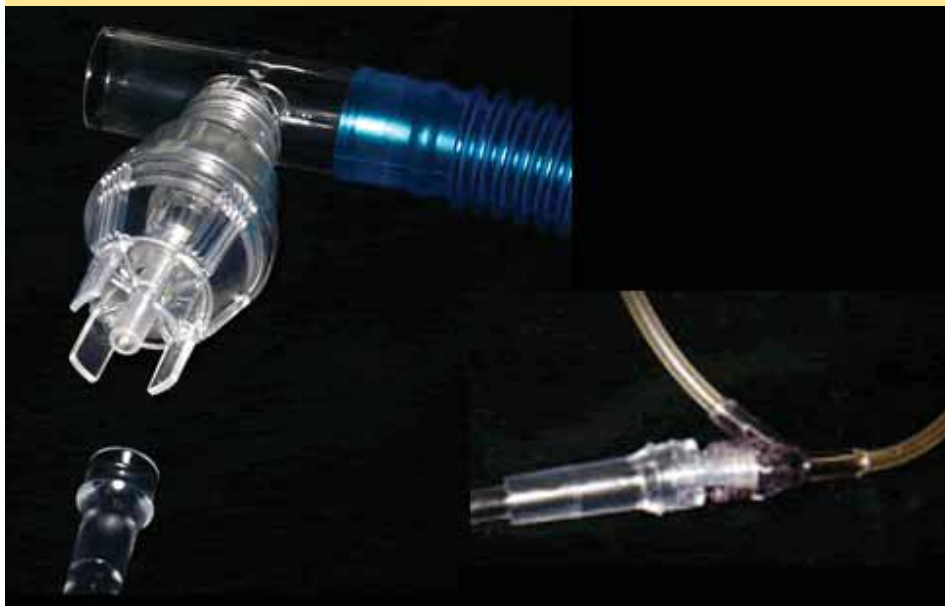
Tubing Misconnections

Tube delivering oxygen fell off nebulizer

The oxygen tubing was connected to a Needleless Access System IV tubing Y-tube
